# Manhole Inspection Summary

Manhole # S39WW\_050MH

Insp Date: **12/18/06 2:26 PM**

**Location** Address: **829 MONTPELIER ST**

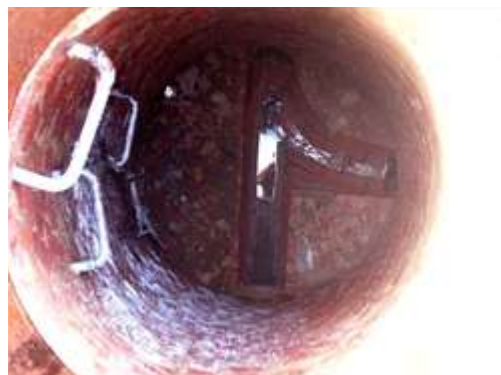
Top View

Frame leaks. Adjustment infiltration.  
Evidence of surcharge - Bench debris.  
Channel debris.

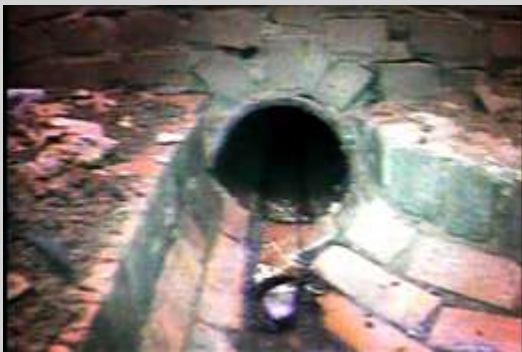
### 8 in. Circular Gravity Sewer Pipe Out @ 12 O'Clock

Barrel deterioration and infiltration.

Invert Depth: **8.05** (ft.) Flow Characteristics: **Slow**

Infiltration: **Evidence** Pipe Seal Cond: **Unknown**

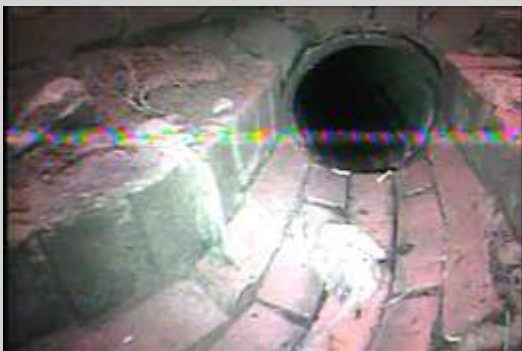
### 8 in. Circular Gravity Sewer Pipe In @ 3 O'Clock

Infiltration: **Evidence** Pipe Seal Cond: **Unknown**

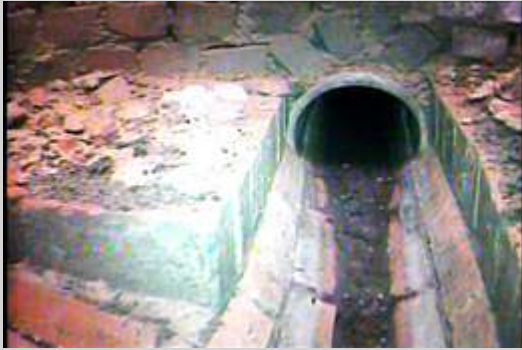
Pipe In @ 6 O'Clock

Deposits: ☐ None ☒ **Mud** ☐ Sludge ☒ **Debris** ☒ **Grease**

Silt Depth: **0.05** (in.)

Deposits Extent: **Light**
